# Manhole Inspection Summary

Manhole # S65O\_\_005MH

Insp Date: **4/23/08 3:55 PM**

**Location** Address: **1301 Anglesea St.**

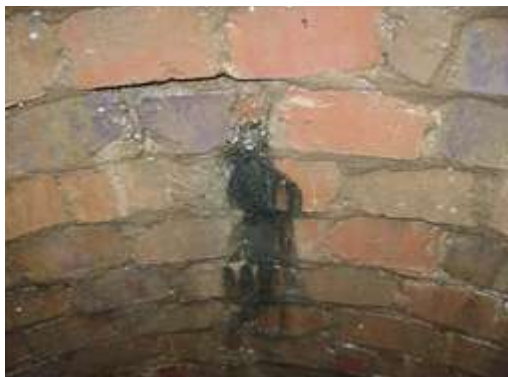
Defect 2

weeper infiltration not visible at inspection, but evidence of one.

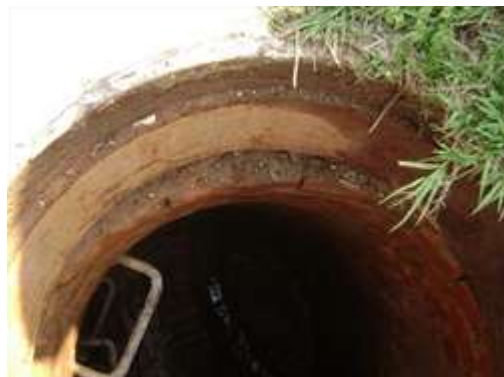
Defect 1

**Frame** Offset: **2** (in.) Condition: ☒ Sound ☐ Cracked ☐ Leaks

frame offset

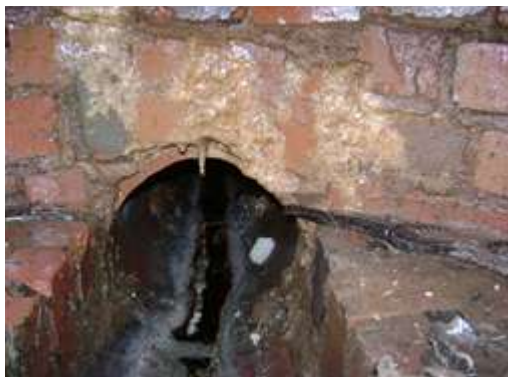
Defect 5

crack at 10:00 on outgoing pipe

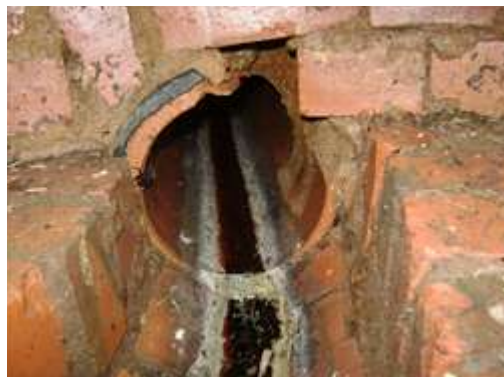
Defect 4

Broken pipe seal and broken pipe on incoming 4 o'clock

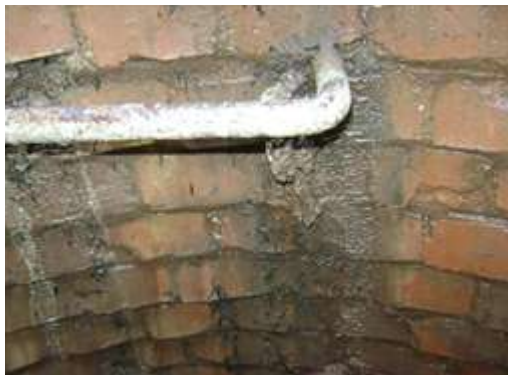
### Defect 3

Infiltration: ☐ None ☐ Joint ☐ Cracks ☒ **Mortar** ☐ Roots ☐ Wall

infiltration in barrel wall

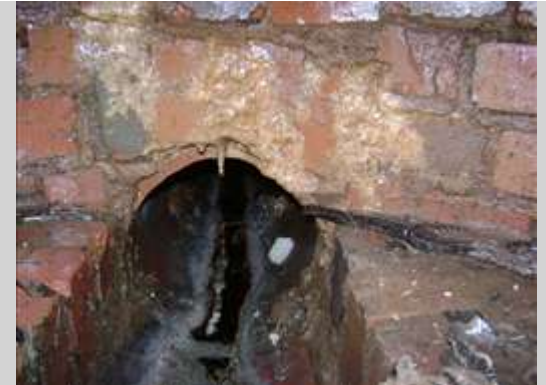
12 O'Clock Outflow

8 in. Circular Gravity Sewer  
Pipe Out @ 12 O'Clock

Pipe Height: **8.4** (in.) Rod and Bar (Angled)  
Pipe Material: **Clay** ☐ Pipe Lined  
Invert Depth: **8.50** (ft.) Flow Characteristics: **Slow**  
Deposits: ☐ None ☐ Mud ☐ Sludge ☐ Debris ☒ Grease  
Silt Depth: **0.125** (in.) Deposits Extent: **Light**  
Infiltration: **None** Pipe Seal Cond: **Sound**

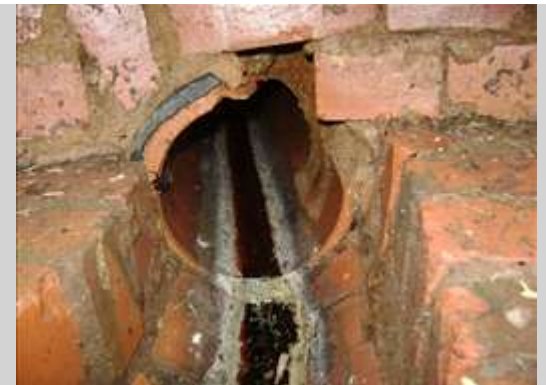
4 O'Clock Inflow

8 in. Circular Gravity Sewer  
Pipe In @ 4 O'Clock

Pipe Height: **8.4** (in.) Rod and Bar (Angled)  
Pipe Material: **Clay** ☐ Pipe Lined  
Invert Depth: **8.00** (ft.) Flow Characteristics: **Slow**  
Deposits: ☒ None ☐ Mud ☐ Sludge ☐ Debris ☐ Grease  
Silt Depth: (in.) Deposits Extent:  
Infiltration: **None** Pipe Seal Cond: **Broken**
